TESTING OF A DELTA IV PAYLOAD ATTACH FITTING (PAF) SUBSTRUCTURE WITH AN INTEGRAL COMPOSITE FLANGE

Air Force Research Laboratory, VSSV
Kirtland AFB, NM USA

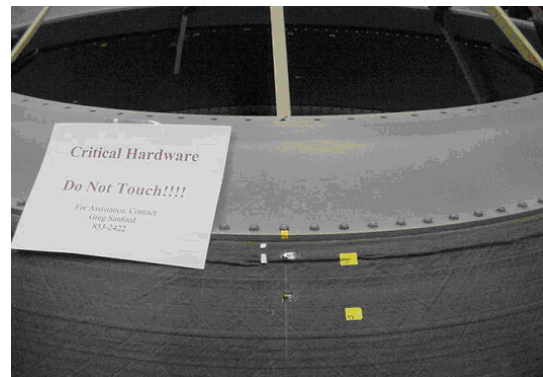
Figure 7. Forward adapter ring bolted to composite flange of test structure

interface. The aft adapter, representing the launch vehicle interface, consisted of a solid aluminum ring and four splice plates. Installation of the aft adapter onto the base plate is shown in Figure 6. Likewise, the forward adapter, representing the payload interface, was constructed of a solid aluminum ring as shown in Figure 7.
